**SQUARE –
A System for Quality Assurance when
Retrofitting Existing Buildings to
Energy Efficient Buildings**

WP6 -National Pilot Project SPAIN

Final report

SPANISH PILOT PROJECT REPORT

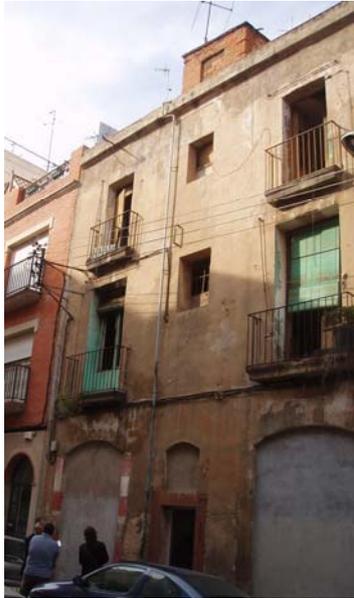
Picture 1. Building state before renovation

The old building was in very bad general condition, without permanent tenants. Some parts have grave structural deficiencies and the general systems were completely obsolete.

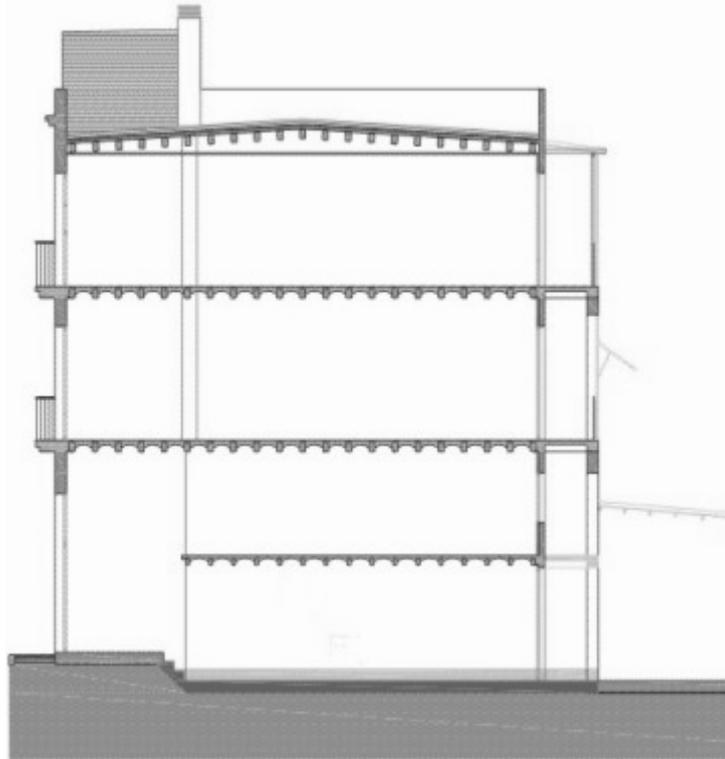
Picture 3. Cross-section of the building initial state

Pilot Project Building Block	Initial state
Address	Sant Joan de Malta street. Barcelona
Number apartments	6
Year of construction	Around 1890
Materials	Brick and stone (walls), wood (beams), flat tiles (roof)
Orientation	45° SW

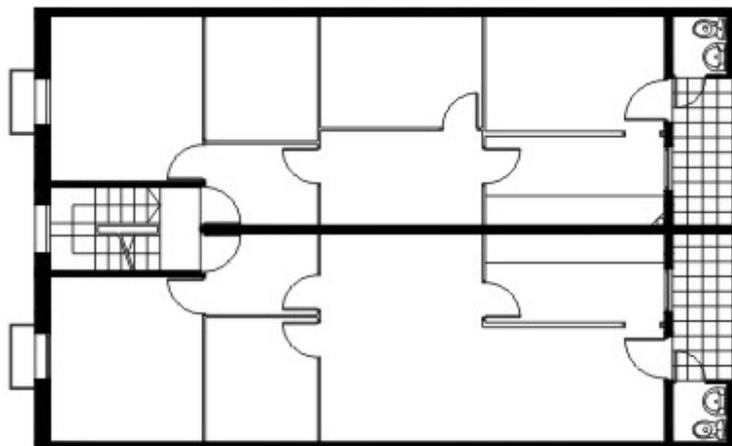
Picture 4. Ground plan of the building initial state

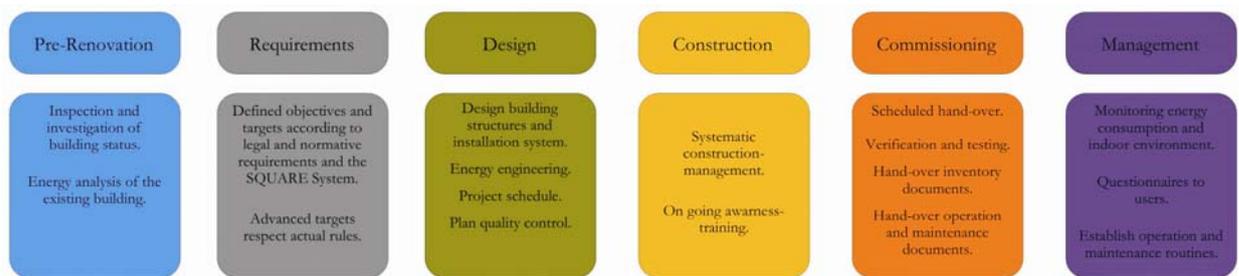
Picture 5.

The general strategy for the renovation process follows the structure of the SQUARE- QA-system, summarized at the following picture.

Overview of SQUARE QA system

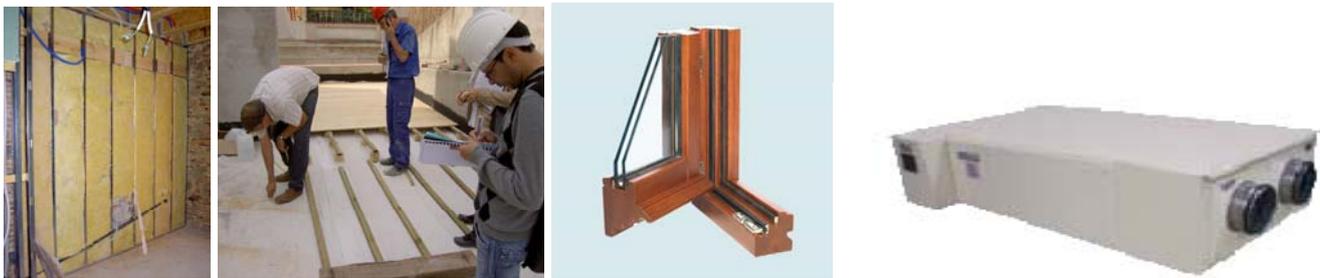
Picture 6. Proposals for better energy efficiency and indoor environment quality

- exterior thermal insulation on the main façade
- internal walls insulation surrounding not heated spaces, and the basement floor
- vented roof
- correction of thermal bridges
- introduce a collective heating system (instead of individual boilers in each flat) and collective hot water generation
- introduce high efficiency boiler (condensation)
- introduce hot water and heating metering (each apartment)

- centralise ventilation (roof air entrance and evacuation) with individual thermal recovery from renovated air flow
- introduce free cooling for intermediate seasons
- improve air tightness using windows without permanent venting
- avoid the capillary moisture from the basement
- prevent eventual flow of radon from basement
- introduce continuous monitoring of energy performance
- encourage of energy-awareness behaviour by users by means of individual temperature control in each apartment, supported by electricity and heat consumption meters.
- rainwater collection

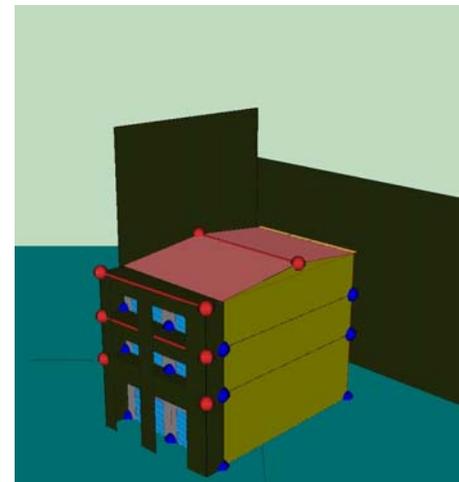
The reformulated project has been tested with official software in order to verify the accomplishment of Spanish Building Energy requirements (CTE) and later to calculate its Energy Certificate. The target was to reach at least the level B.

The Certificate will be issued after the renovation is completed. Targets are to keep heating needs below 25 kWh/m², and emissions from thermal consumption (heating, cooling and HW) below 9,4 kg CO₂/m².

Certificación Energética de Edificios Indicador kgCO ₂ /m ²	Edificio Objeto	Edificio Referencia
<5,9 A		
5,9-9,6 B	9,4 B	
9,6-14,9 C		
14,9-22,9 D		20,6 D
>22,9 E		
F		
G		
Demanda calefacción kWh/m ²	C 25,2	D 42,8
Demanda refrigeración kWh/m ²	B 4,1	C 5,4
Emisiones CO ₂ calefacción kgCO ₂ /m ²	C 5,3	E 13,7
Emisiones CO ₂ refrigeración kgCO ₂ /m ²	C 1,5	D 2,0
Emisiones CO ₂ ACS kgCO ₂ /m ²	A 2,6	D 4,9

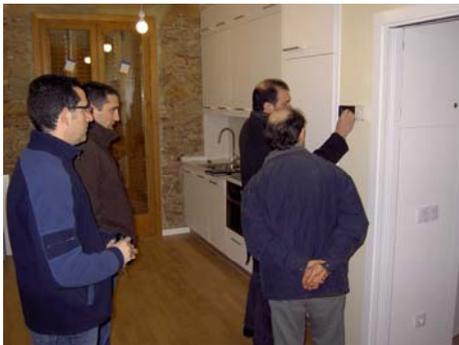
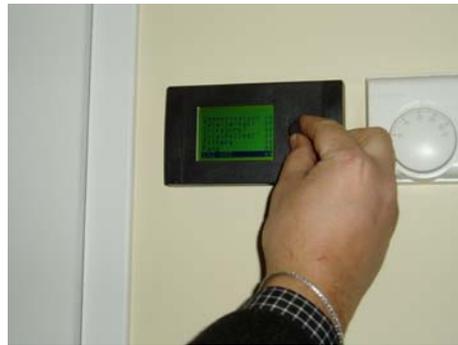
Picture 1: Ventilation system commissioning:

Ventilation commissioning tasks has been:

- Ducts testing
- Verify temperature and air quality sensors

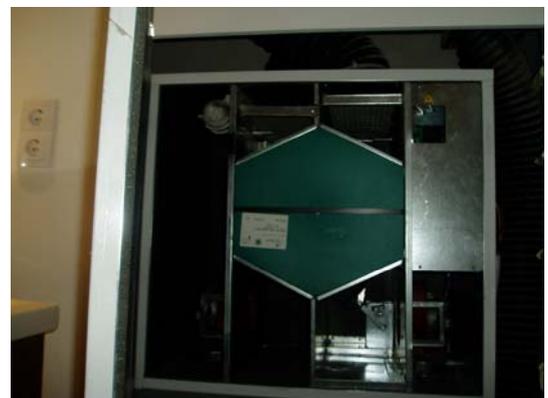
Picture 2: Open individual ventilation and heat recovery equipment

All apartments are equipped with a ventilation unit, (with filters, fans, heat exchanger and regulation device with display). This system is very innovative in Spain and no new apartment user has been seen it before. So, it's very important to explain them how the system works, and the need to change the old behaviour about ventilation in order to improve its thermal performance, and indoor air quality.

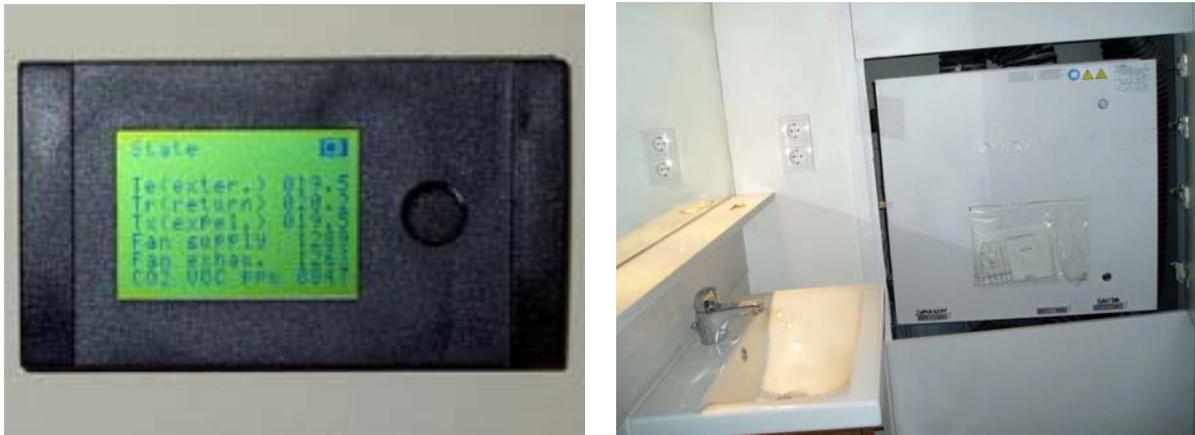
Picture 3: Ventilation equipments: air quality control display (left) and heat exchanger for thermal recovery at the bathroom (right)

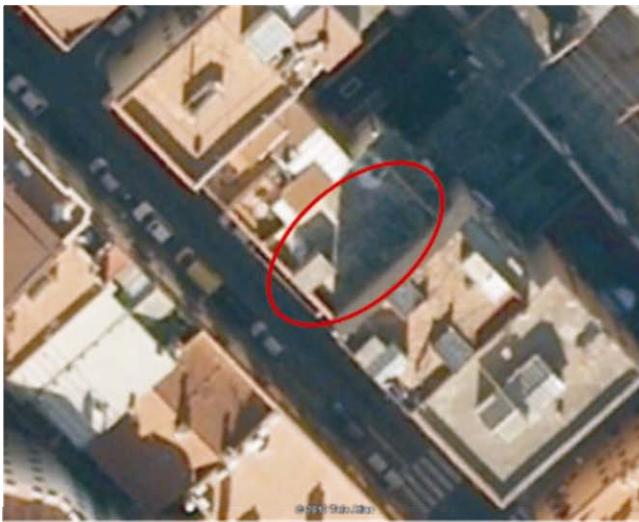
Building aerial view

- 6 apartements
- Exterior walls, floor and roof without insulation
- Windows in very bad state
- Low confort,
- No heating system
- High operation costs
- Structural damages

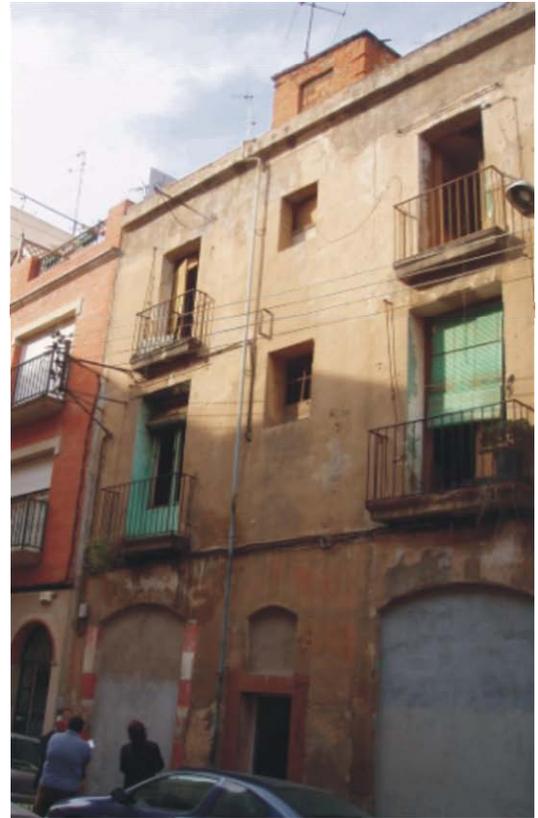
Building main facade

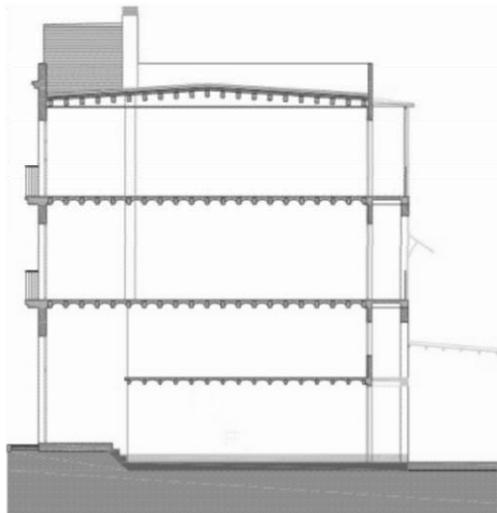
Former cross-section of the buiolding initial state

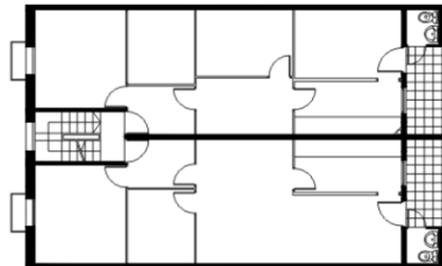
Former floor plan of the building

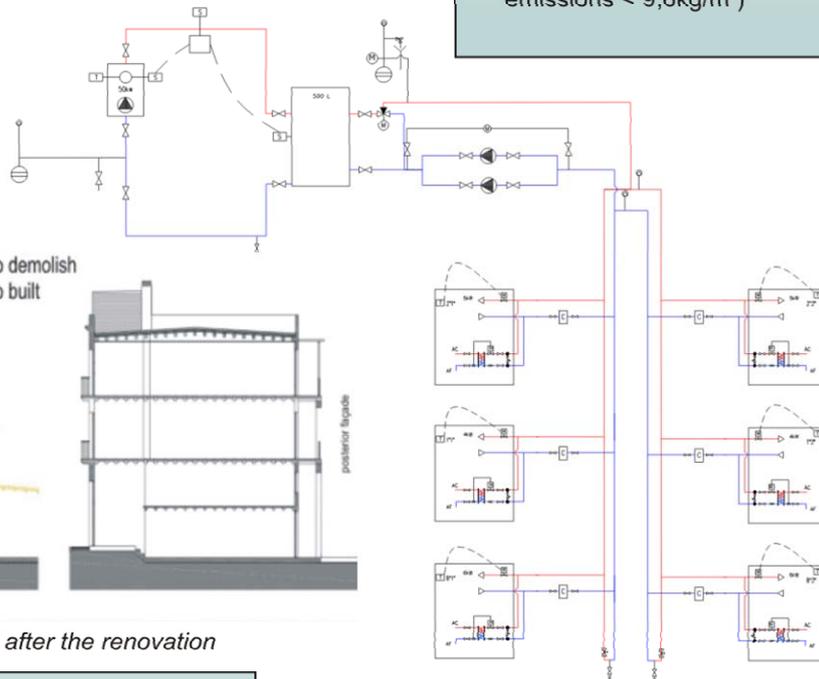
Space heating and hot water production system hydraulic scheme

Collective heating and hot water production:

- Centralized heat production
- Highly efficient boiler
- Instantaneous heat exchanger
- Heated floor area: 324 m^2
- Installed heating capacity: 76kW
- Spec. Heating capacity: 235W/m^2
- Total estimated space heating energy : 8.175 kWh/a
- No solar installation because of the shadow on the roof.

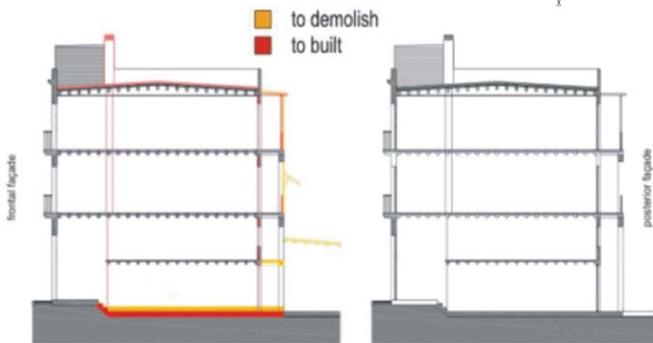
Cross-section before and after the renovation

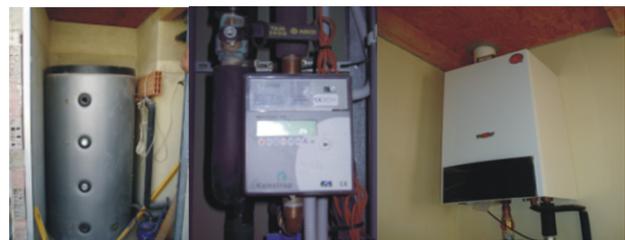
Hot water tank, thermal energy meter and condensation boiler

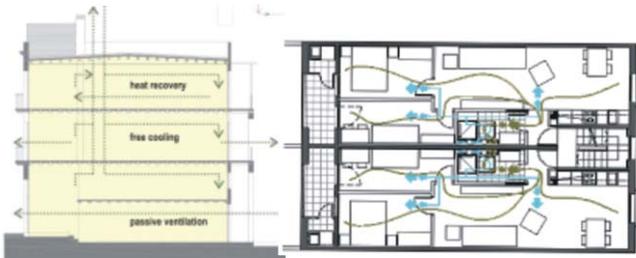
Ventilation concept

Centralised ventilation:

- roof air entrance and evacuation
- individual energy recovery from renovated air flow
- Air energy recovery unit:
 - High efficiency >90%
 - Free cooling bypass
 - 1 unit per apartment
- Natural crossed ventilation controlled by the users is possible though not recommended.

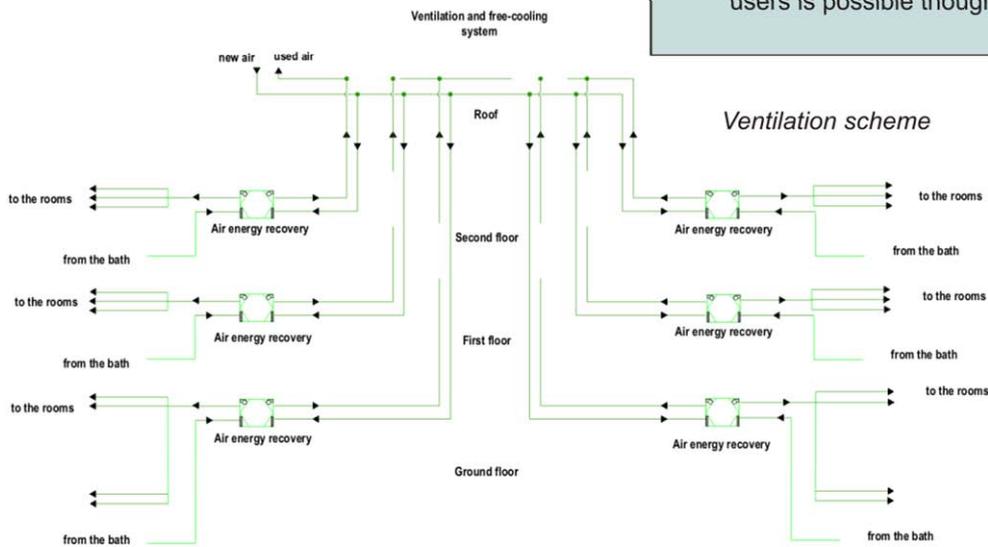
Ventilation scheme

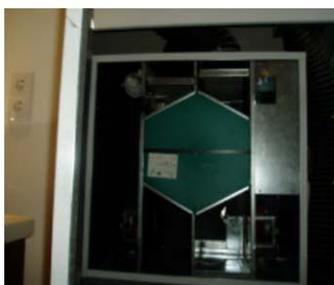
Opened individual ventilation and heat recovery equipment

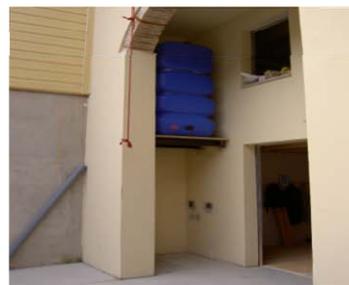
Rainwater harvesting

Rain water collection:

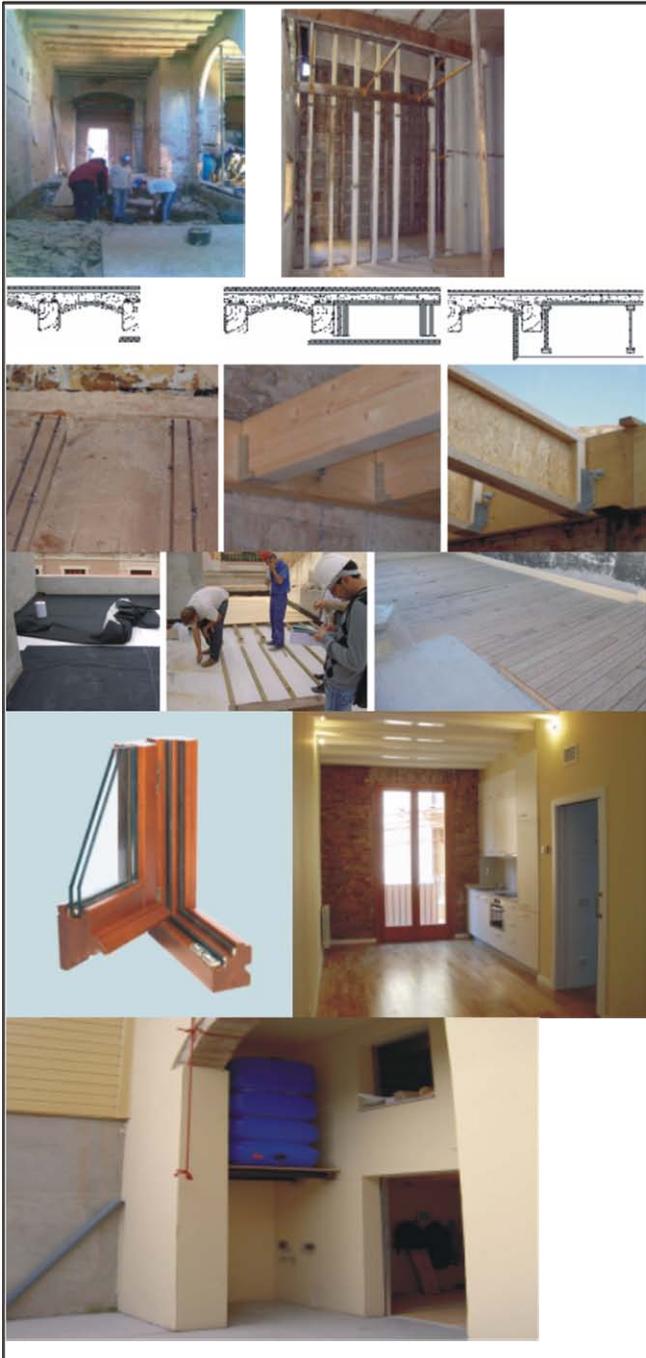
Construction progress

- Demolishment and preventive works.
- Construction of the new sewer.
- Reinforcement the existing beams.
- Installation of new timber beams.
- Step the capillary moisture from the basement.
- Realisation of a waterproof and vented roof.
- Pose of the facade and internal walls' insulation.
- Improvement of the air tightness:
Use of new windows: wood frame, 4 -9- 5 double glazing.
- Installation of the rainwater harvesting sytem.
The ground floor dwellings uses rain water for the garden.
